SERVICE BULLETIN

TS-930S Low RX Sensitivity

3.29.83

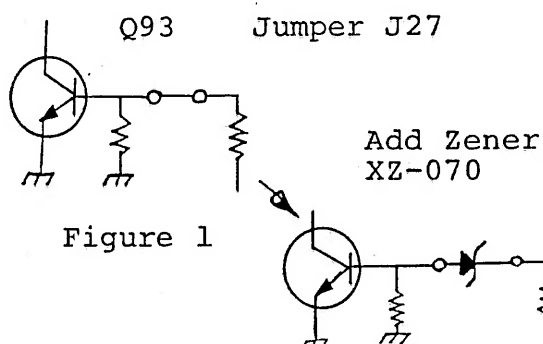
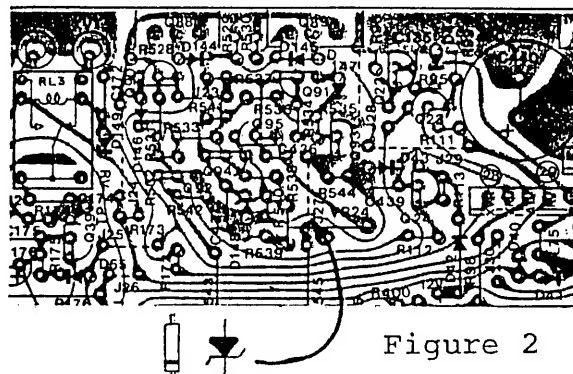
A loss of receiver sensitivity (6-30db) may be caused by shorted switching diodes in the Signal Unit (X57-1000-XX). The following procedure will increase the capability of the unit to withstand high RF voltage levels.

1. Replace Signal unit jumper J27 with an XZ-070 zener diode. (PCB coordinate C-1, see figure 2.)
